ASHLAND SCHOOL DISTRICT
DISTRICT WIDE HVAC UPGRADES PROJECT
BELLVIEW ELEMENTARY SCHOOL
ADDENDUM 1

Regulated Building Materials Survey

**Bellview Elementary School
1070 Tolman Creek Road
Ashland, Oregon 97520**

G2 Project #: 21-6605

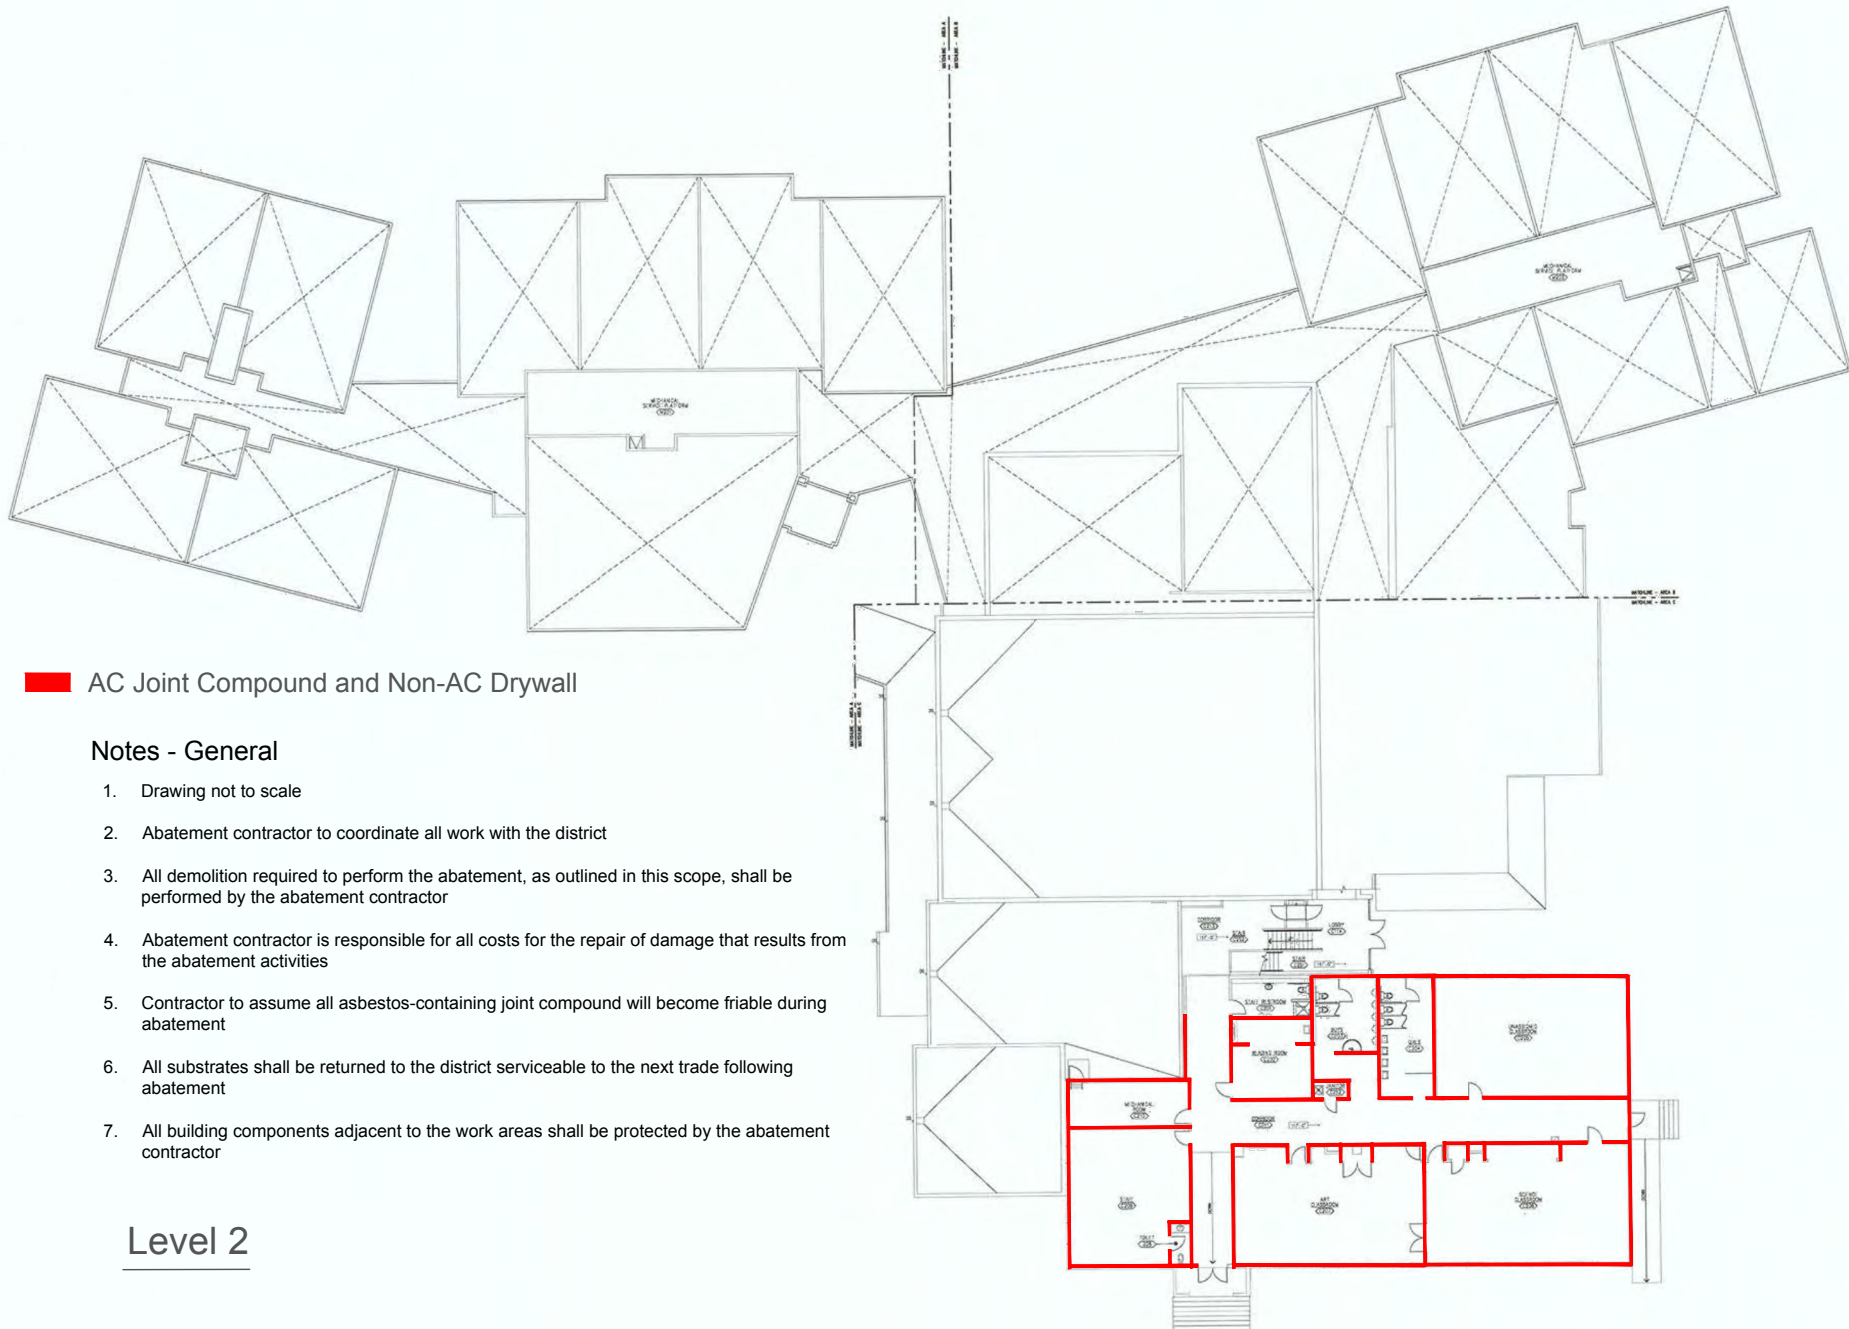
Asbestos-Containing Materials Identified							
HM No. †	Material Description	Material Location	No. of Samples	Approx. Quantity	Asb. Type & %	Condition	Friable Y/N
20, 21**	Drywall and Joint Compound (Old Building Walls)	Old Building - Throughout	4	1,015 sq. ft.	DW - ND JC - 2% Chrysotile	Good	N*

■ AC Joint Compound and Non-AC Drywall

1. Drawing not to scale
2. Abatement contractor to coordinate all work with the district
3. All demolition required to perform the abatement, as outlined in this scope, shall be performed by the abatement contractor
4. Abatement contractor is responsible for all costs for the repair of damage that results from the abatement activities
5. Contractor to assume all asbestos-containing joint compound will become friable during abatement
6. All substrates shall be returned to the district serviceable to the next trade following abatement
7. All building components adjacent to the work areas shall be protected by the abatement contractor

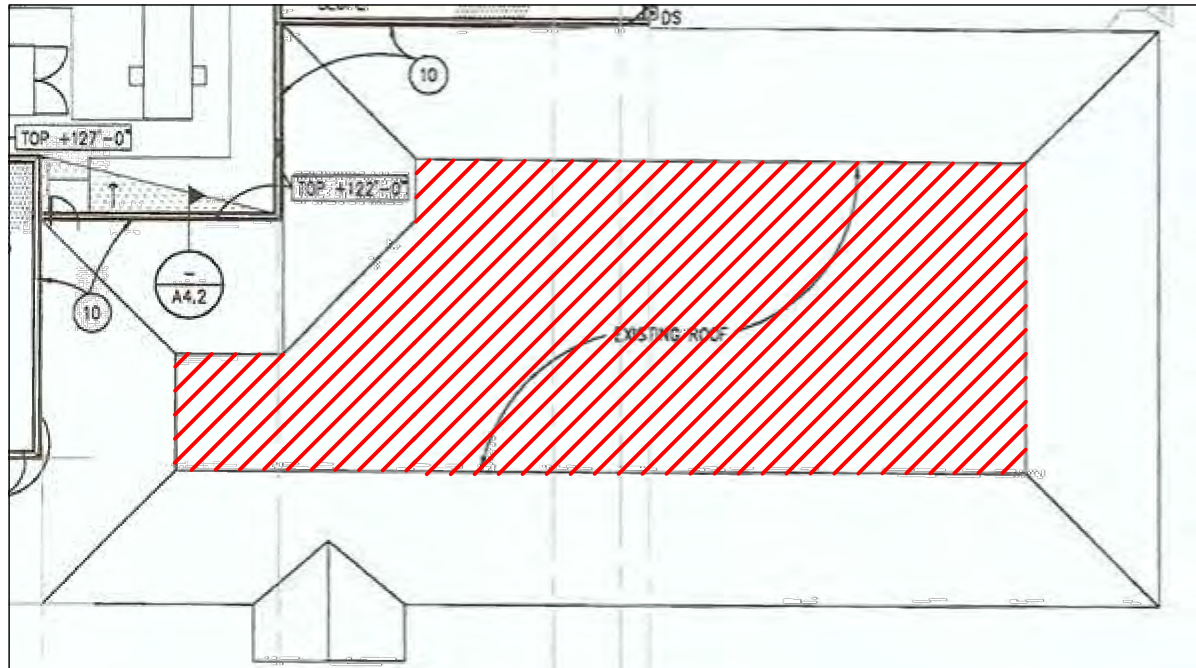
Asbestos-Containing Materials Identified							
HM No. †	Material Description	Material Location	No. of Samples	Approx. Quantity	Asb. Type & %	Condition	Friable Y/N
18	Built-Up Roof, Older	Old Building Membrane Roof	3	1,720 sq. ft.	Silver Paint - 2% Chrysotile Mastic - 5% Chrysotile Tar - ND Felt - ND	Good	N*

Built-Up Roof with AC Silver Paint, AC Mastic, and Non-AC Tar and Felt

1. Drawing not to scale
2. Abatement contractor to coordinate all work with the district
3. All demolition required to perform the abatement, as outlined in this scope, shall be performed by the abatement contractor
4. Abatement contractor is responsible for all costs for the repair of damage that results from the abatement activities
5. Contractor to assume all asbestos-containing roofing materials will become friable during abatement
6. All substrates shall be returned to the district serviceable to the next trade following abatement
7. All building components adjacent to the work areas shall be protected by the abatement contractor
