**Enclosed Seismic Rehabilitation Reports**

Seismic Evaluation Report For:

## JOHN TUCK ELEMENTARY SCHOOL

209 NW 10th St, Redmond, OR 97756  
Redmond School District

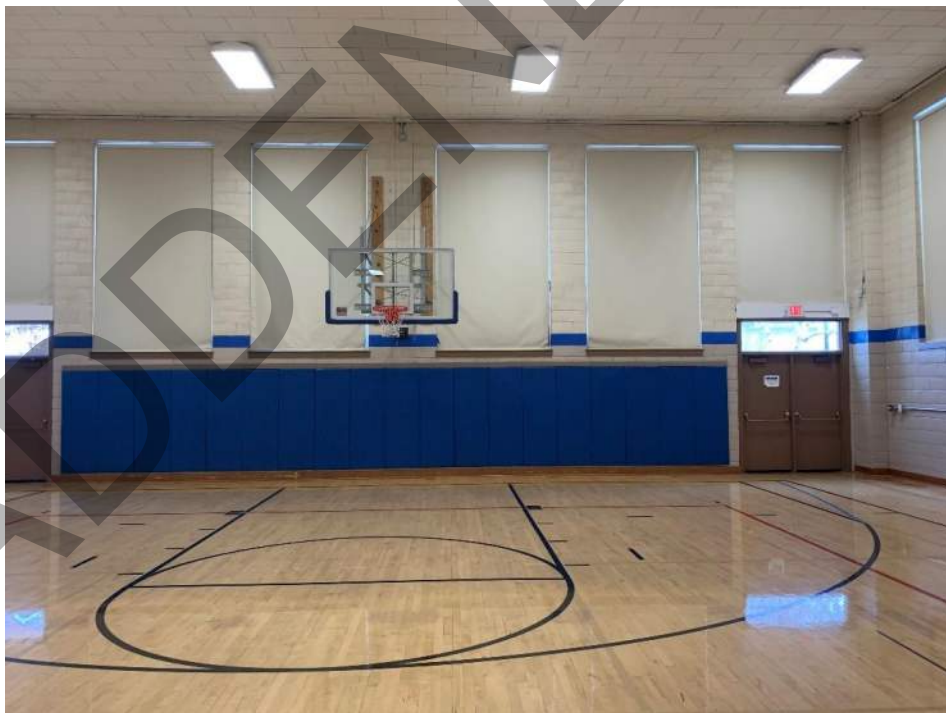
Figure 6: GYM INTERIOR

Bowstring trusses are markedly under-designed, exhibiting on-going symptoms of structural distress and can no longer be relied upon to support code prescribed gravity loading. The trusses will be retrofit and strengthened to support code required gravity loading. This is deficiency/repair/plan note S13.
