LEBANON COMMUNITY SCHOOL DISTRICT  
SEVEN OAK MIDDLE SCHOOL GYM  
SEISMIC UPGRADE  
REQUEST FOR PROPOSAL (RFP)  
ADDENDUM 1

## SEVEN OAK MIDDLE SCHOOL GYMNASIUM

550 Cascade Dr, Lebanon, OR 97355  
Lebanon School District

December 2024  
P-2940-24

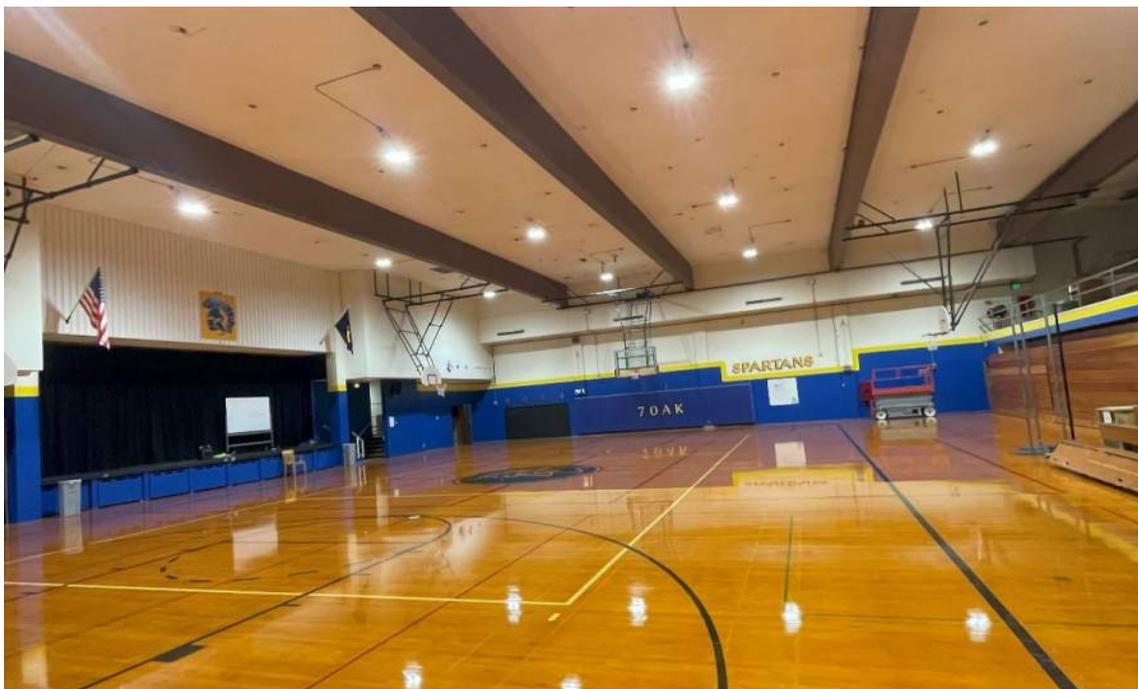
Figure 2: Gymnasium with mezzaine (right) and stage (left)

<input type="checkbox"/>	<input checked="" type="checkbox"/>	<input type="checkbox"/>	<input type="checkbox"/>				
<b>C</b>	<b>NC</b>	<b>N/A</b>	<b>U</b>	MEZZANINES: Interior mezzanine levels are braced independently from the main structure or are anchored to the seismic-force-resisting elements of the main structure.	5.4.1.3	A.2.1.3	In-plane attachments not observed at mezzanine.
<input type="checkbox"/>	<input checked="" type="checkbox"/>	<input type="checkbox"/>	<input type="checkbox"/>				
<b>Building System—Building Configuration</b>							
<b>C</b>	<b>NC</b>	<b>N/A</b>	<b>U</b>	WEAK STORY: The sum of the shear strengths of the seismic-force-resisting system in any story in each direction is not less than 80% of the strength in the adjacent story above.	5.4.2.1	A.2.2.2	
<input type="checkbox"/>	<input type="checkbox"/>	<input checked="" type="checkbox"/>	<input type="checkbox"/>				
<b>C</b>	<b>NC</b>	<b>N/A</b>	<b>U</b>	SOFT STORY: The stiffness of the seismic-force-resisting system in any story is not less than 70% of the seismic-force-resisting system stiffness in an adjacent story above or less than 80% of the average seismic-force-resisting system stiffness of the three stories above.	5.4.2.2	A.2.2.3

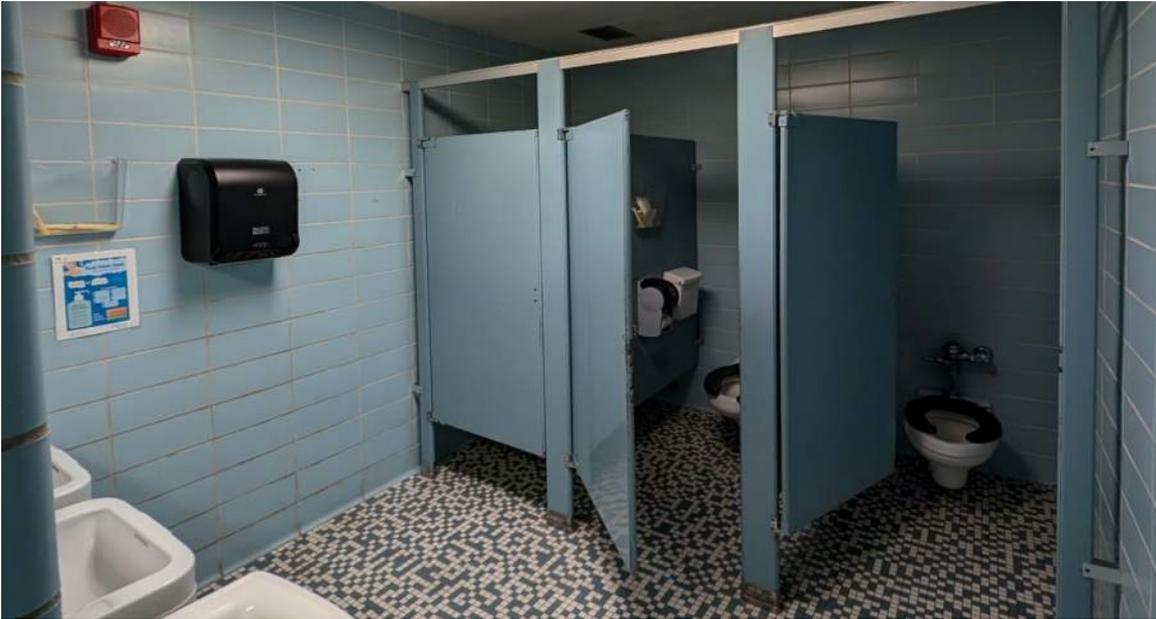
- o ASCE 41-17 Building Types:
  - o C2a, URM
- o Roof Structure:
  - o The roof consists of a plywood sheathed diaphragm supported by light timber rafters spanning to perimeter bearing walls and an interior post and beam line.
- o Walls:
  - o Reinforced cast-in-place concrete walls and reinforced concrete pilasters.
  - o Under-reinforced masonry bearing walls and under-reinforced heavy masonry partitions.
- o Floor Structure and Foundation:
  - o Slab-on-grade with concrete stem walls and strip footings
- o Notable Structural Features/Concerns:
  - o The locker rooms' walls in the shower stalls are constructed with unreinforced 4" glazed multi-wythe tile.

Figure 5: Clay tile restroom walls
