Limited Regulated Building Materials Survey

**Lincoln Savage Middle School - Gym Building Seismic Upgrade
8551 New Hope Road
Grants Pass, Oregon 97527**

G2 Project #: G25-333

October 30, 2025

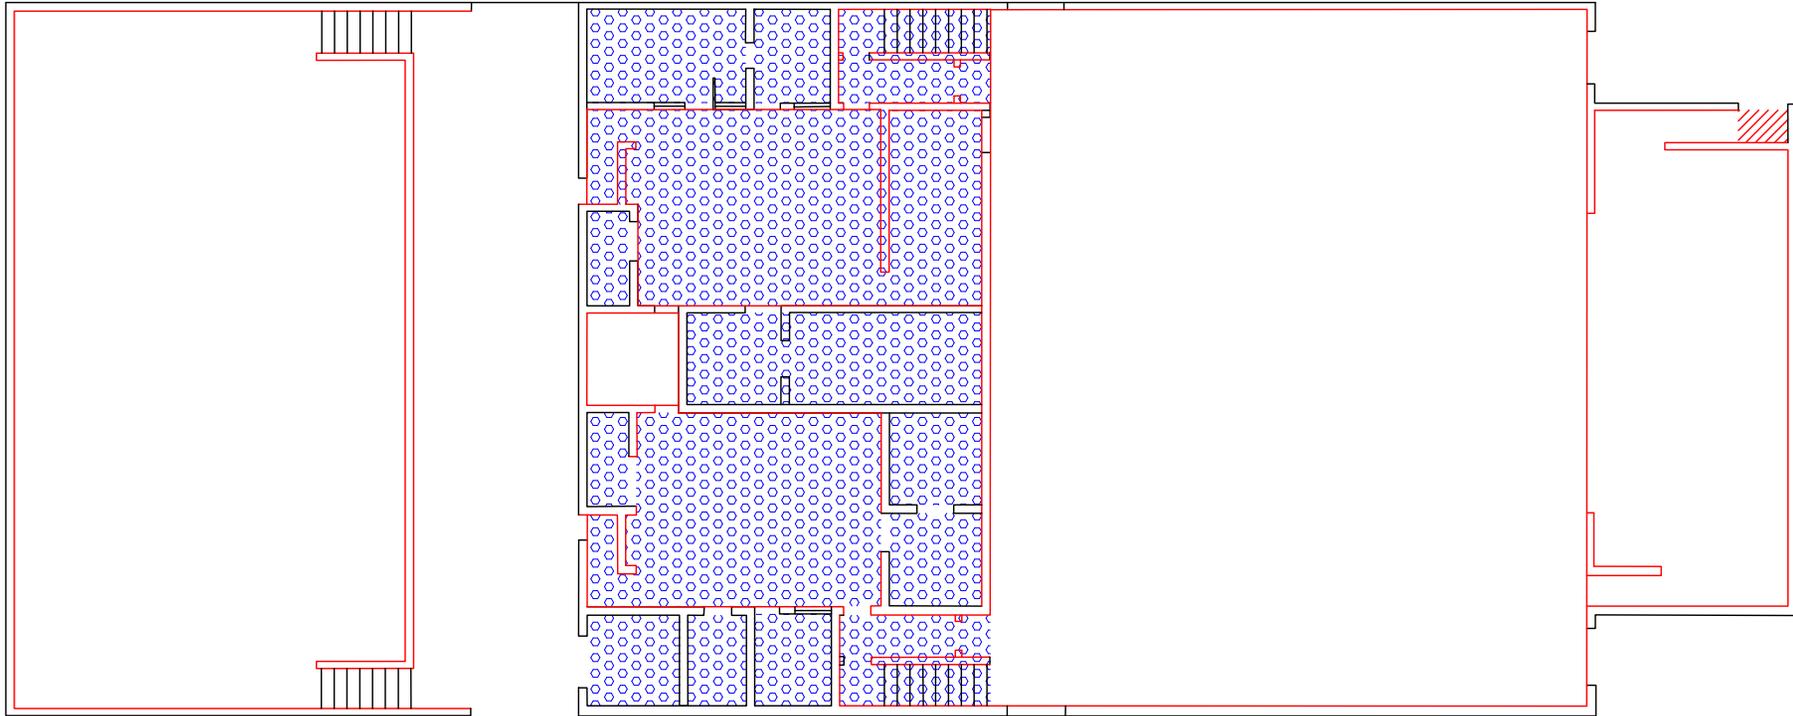
Floor Tile, 9" x 9" Beige with Tan Specks, and Black Mastic

ACM not shown: Cement Asbestos Board (Transite Panels)
 Roof Patch and Repair Material, Black (Older)
 Pipe Fitting Insulation (Presumed)
 Vibration Joint Cloth (Presumed)

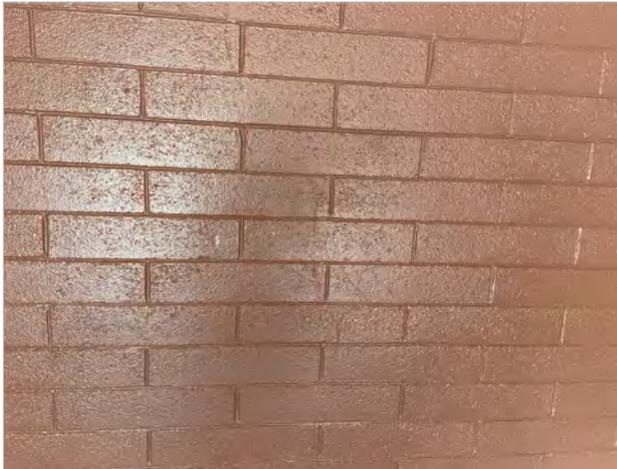
HM#1: CMU Mortar, Gray

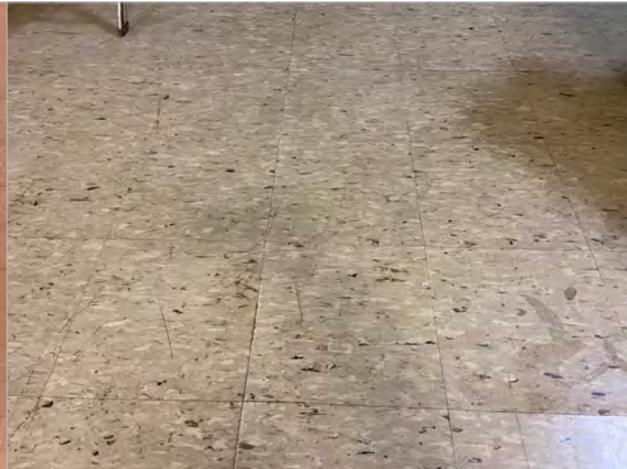
HM#2: Floor Tile, 12" x 12" Off-White w/ Brown Specks, and Tan Glue

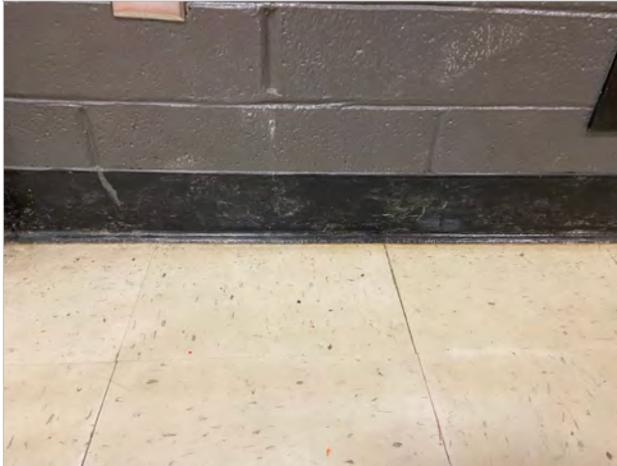
HM#3: Cove Base, 4" Black, and Brown Adhesive

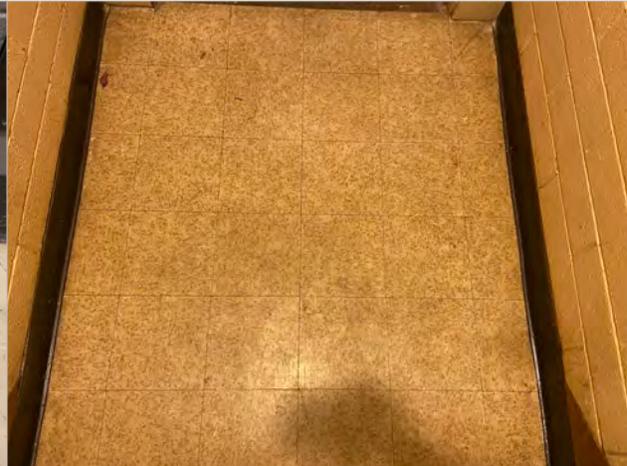
HM#4: Floor Tile, 9" x 9" Beige w/ Tan Specks, and Black Mastic

All identified and presumed ACM must be removed by a licensed asbestos abatement contractor, or other certified individual, prior to impact if they are to be disturbed during renovation activities. ACM remaining in the building should be managed in good condition, under an Operations and Maintenance Plan, and checked regularly for damage.

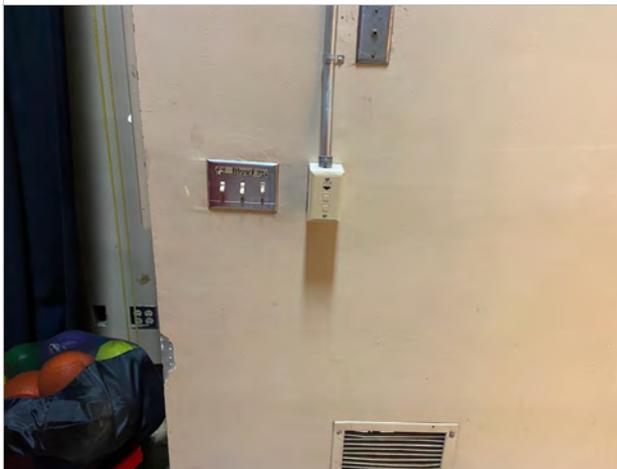
HM#5: Drywall and Joint Compound

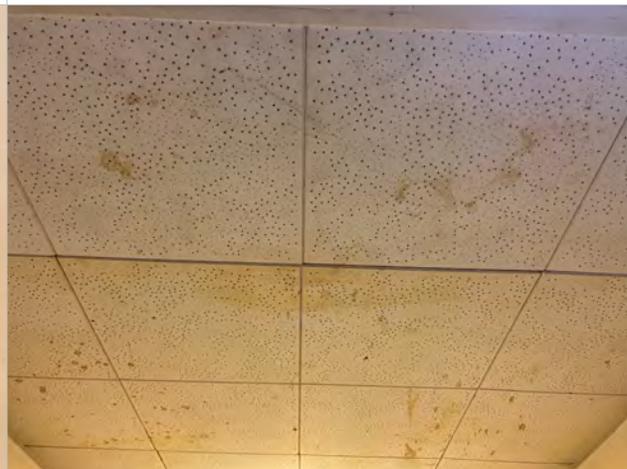
HM#6: Ceiling Tile, 12" x 12" Pinhole

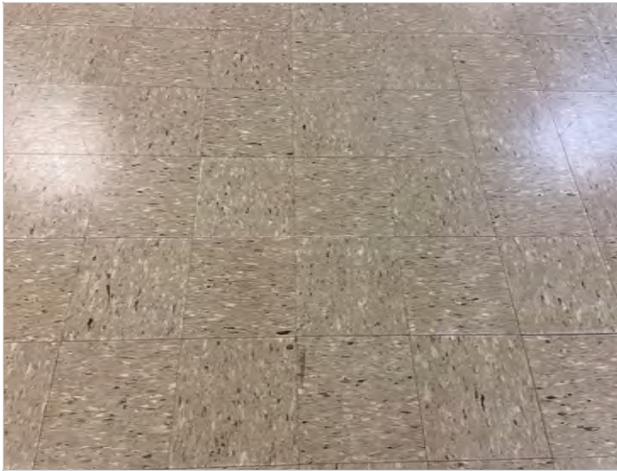
HM#7: Floor Tile, 12" x 12" Olive w/ Brown Streaks, and Tan & Black Mastic

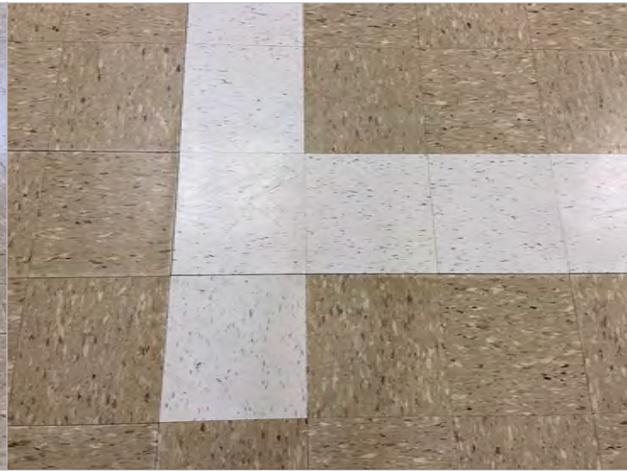
HM#8: Floor Tile, 12" x 12" White (Replacement), and Tan & Black Mastic

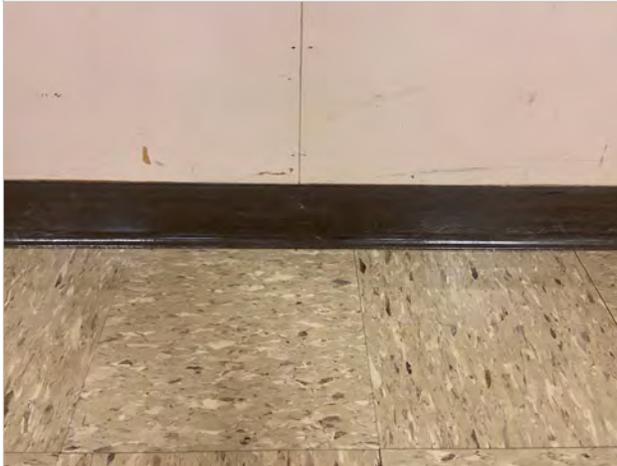
HM#9: Cove Base, 4" Brown, and Brown Adhesive

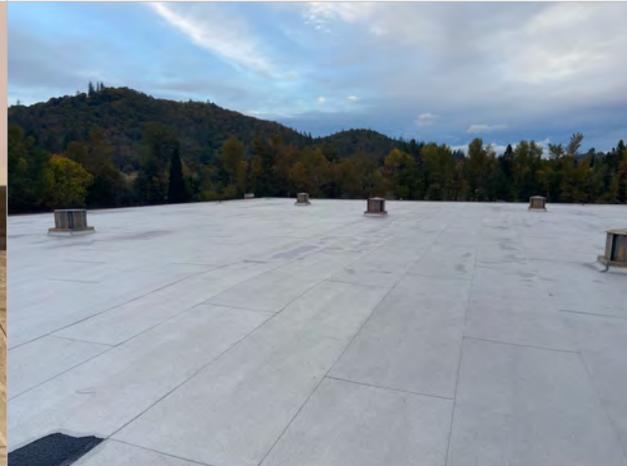
HM#10: Built-Up Roof (Upper)

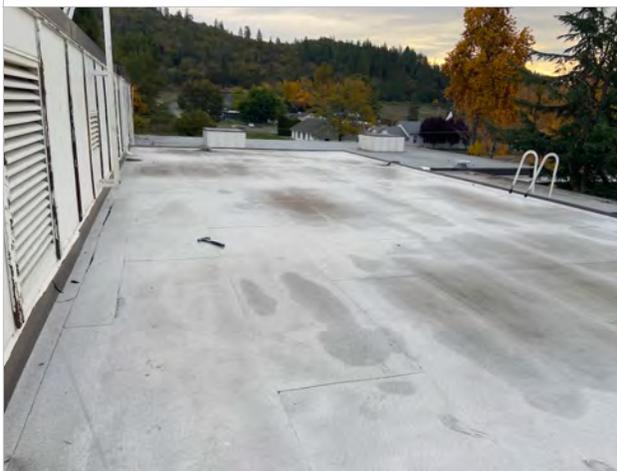
HM#11: Built-Up Roof (Lower)

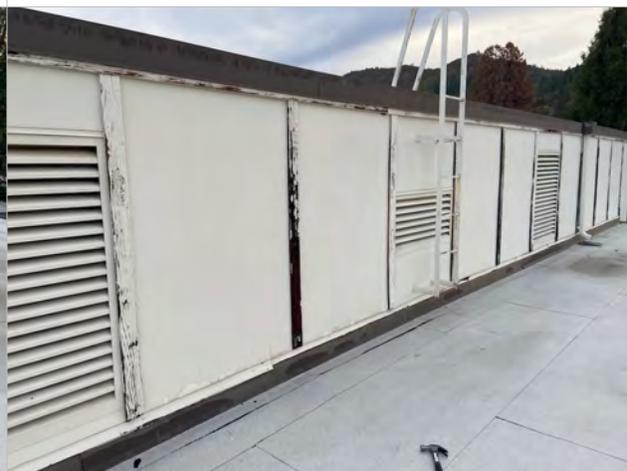
HM#12: Transite Panels

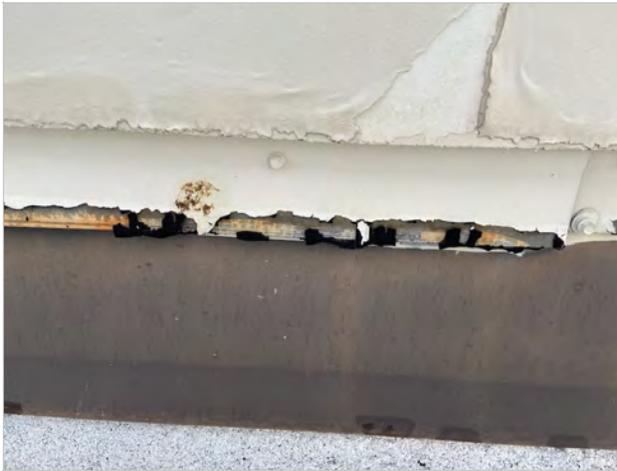
HM#13: Roof Patch & Repair, Black (Newer)

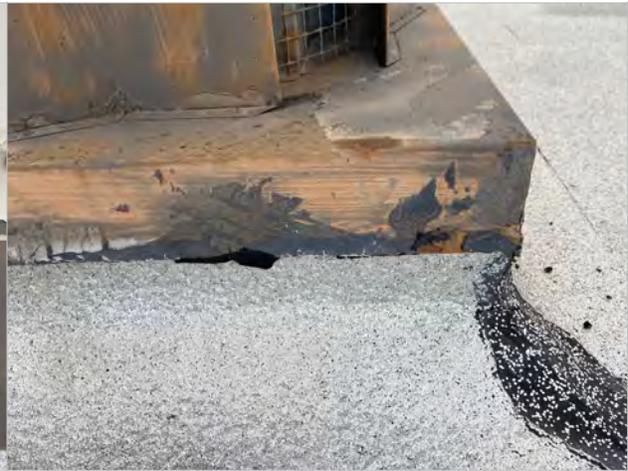
HM#14: Roof Patch & Repair, Black (Older)

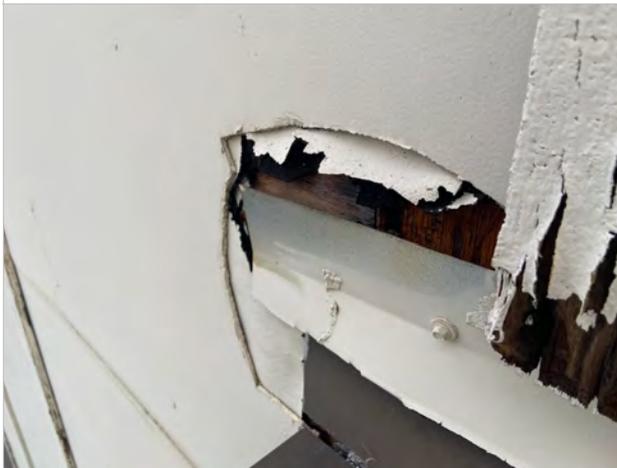
HM#15: Building Felt, Black

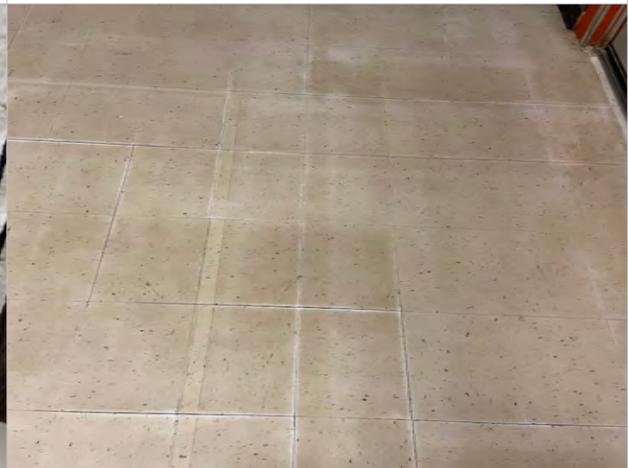
HM#16: Floor Tile, 12" x 12" Off-White w/ Gray Specks, and Tan Glue

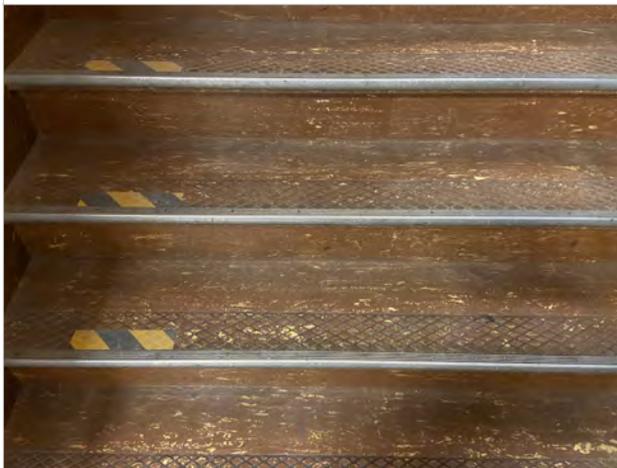
HM#17: Stair Tread, Brown, and Brown Adhesive

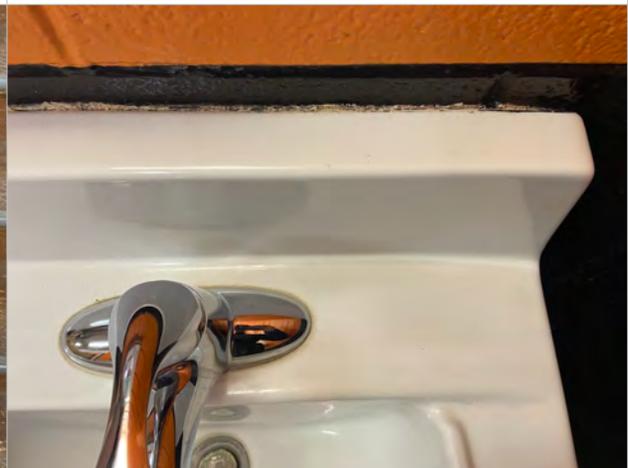
HM#18: Caulking, Beige

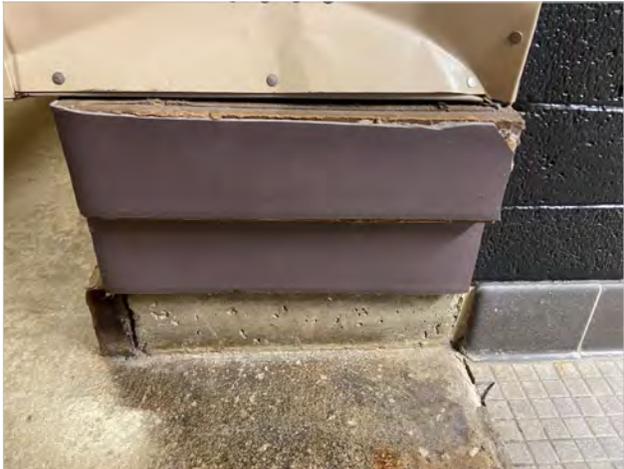
HM#19: Cove Base, 4" Purple, and Off-White Adhesive

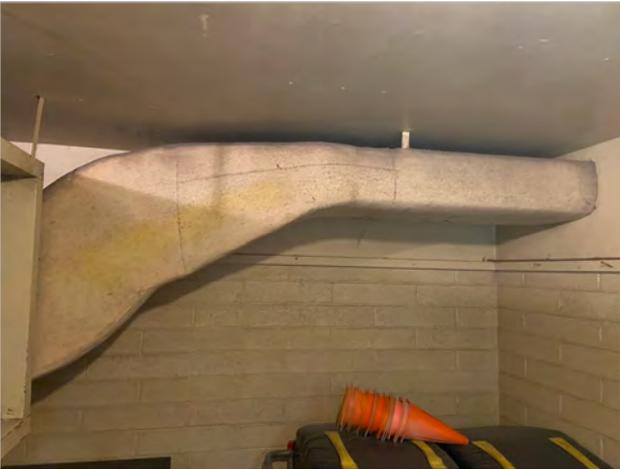
HM#20: Duct & Pipe Wrap, Tan

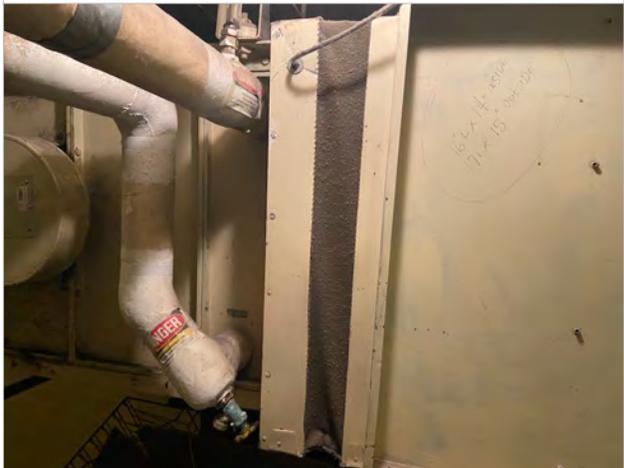
HM#21: Pipe Insulation Hard Fittings (Presumed)

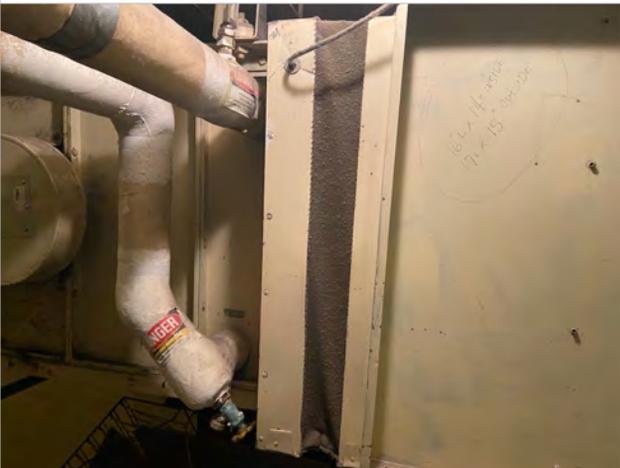
HM#22: Vibration Joint Cloth (Presumed)
