OR24-051 - NEWBERG CITY HALL - ROOFING & WINDOW RENEWAL
 414 E. FIRST ST., NEWBERG, OR 97132
 ROOFING SCOPE BID SET

Newberg City Hall - Roof Replacement Project
414 E 1st Street
Newberg, Oregon 97132

City of Newberg
Limited Asbestos Survey - Roof Replacement Project
Newberg City Hall - 414 E. 1st Street, Newberg, OR
February 27, 2026

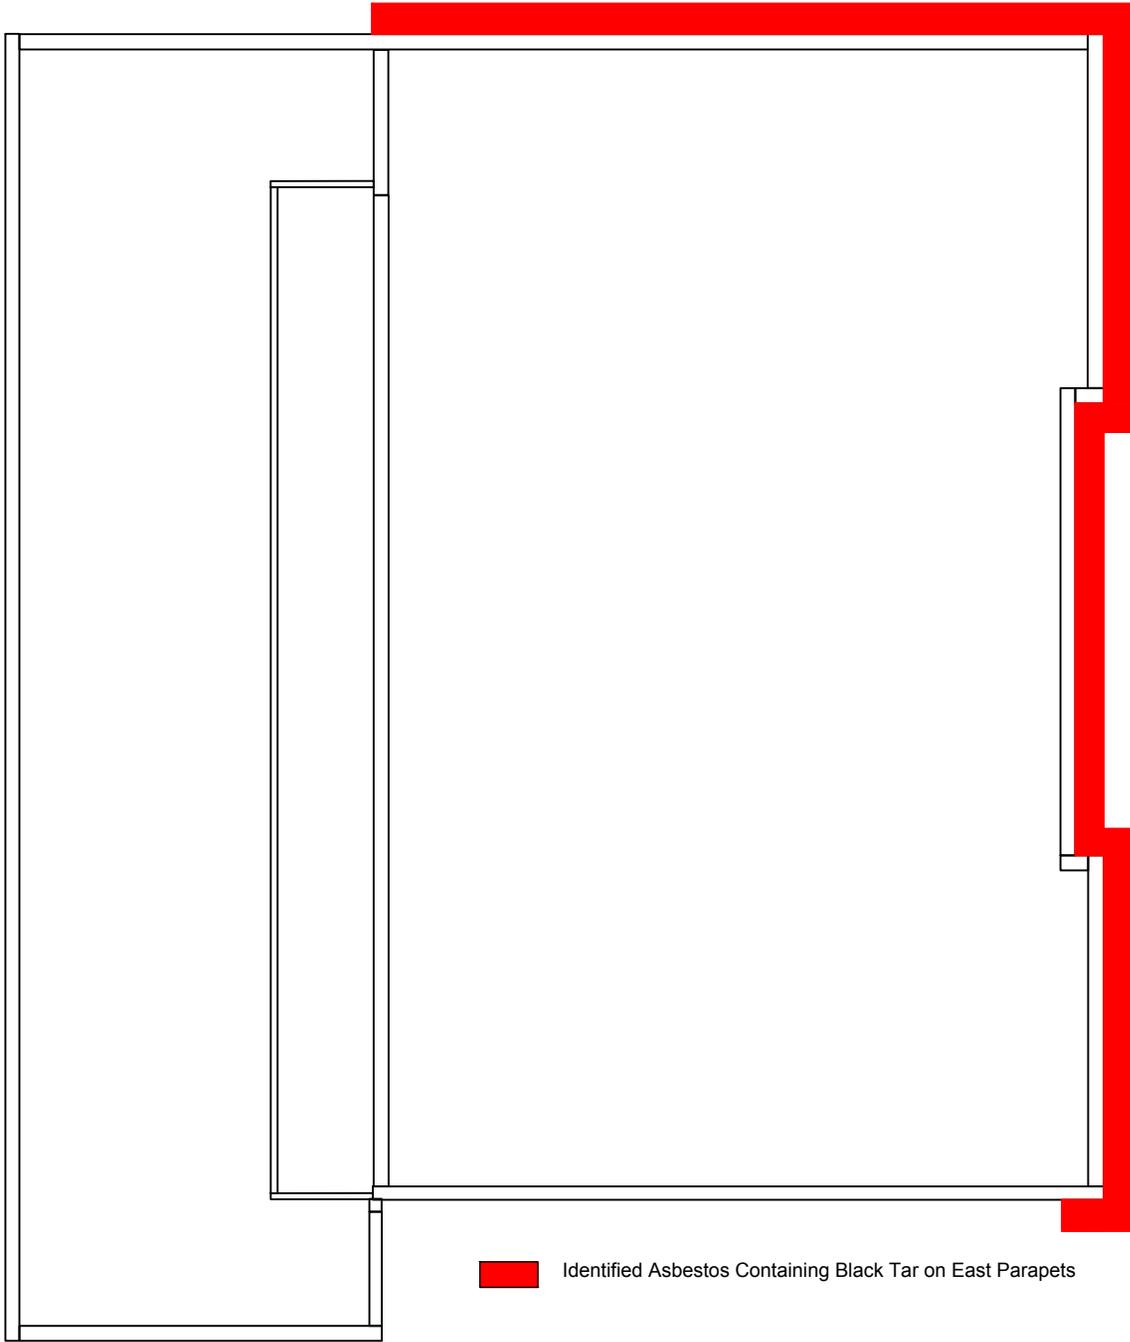
Results of the limited survey have determined that the black tar material on the decorative ledge of the East Roof is an ACM. The material was observed to be in poor condition at the time of the survey.

Identified Asbestos Containing Black Tar on East Parapets

All identified and presumed ACM must be removed by a licensed asbestos abatement contractor, or other certified individual, prior to impact if they are to be disturbed during renovation activities. ACM remaining in the building should be managed in good condition, under an Operations and Maintenance Plan, and checked regularly for damage.

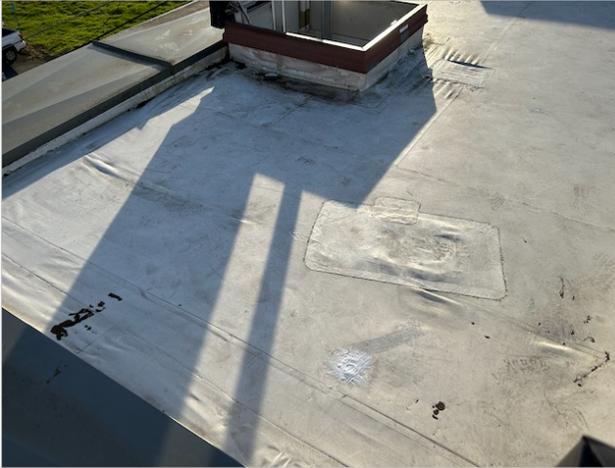
HM#1: Membrane Roof Core #1

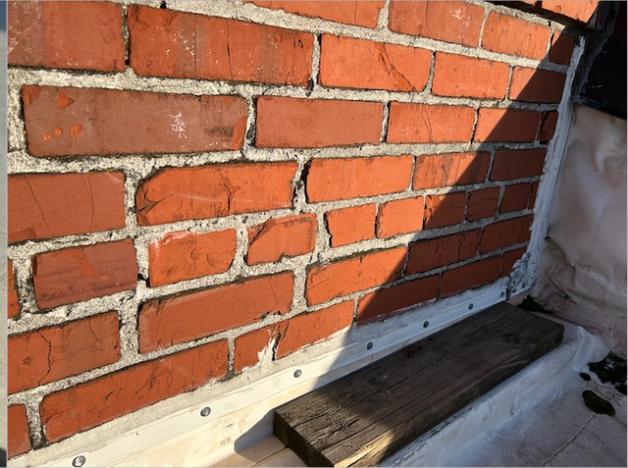
HM#2: Sealant, White, on Flashing

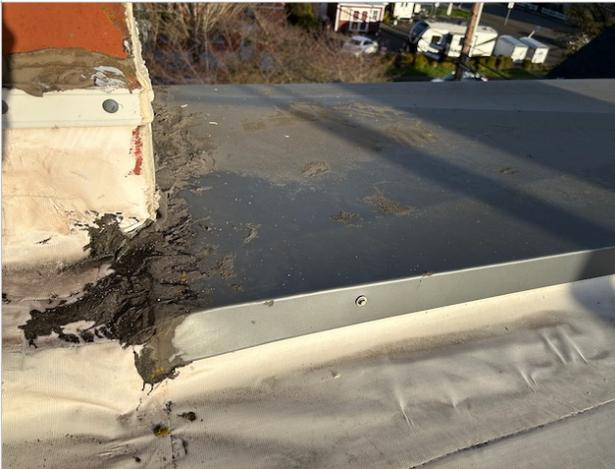
HM#3: Sealant, Dark Gray, on Flashing

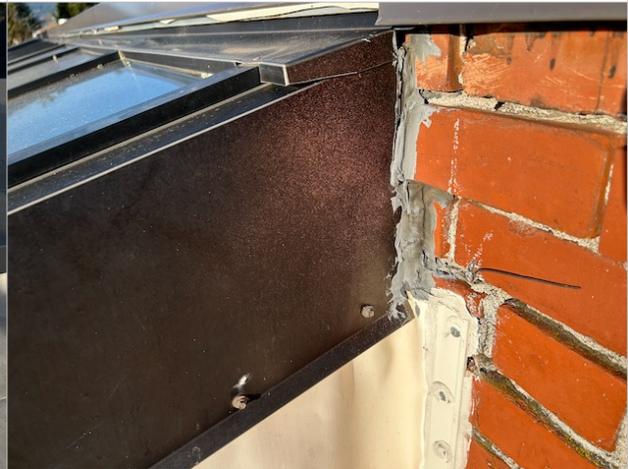
HM#4: Sealant, Light Gray, on Skylight

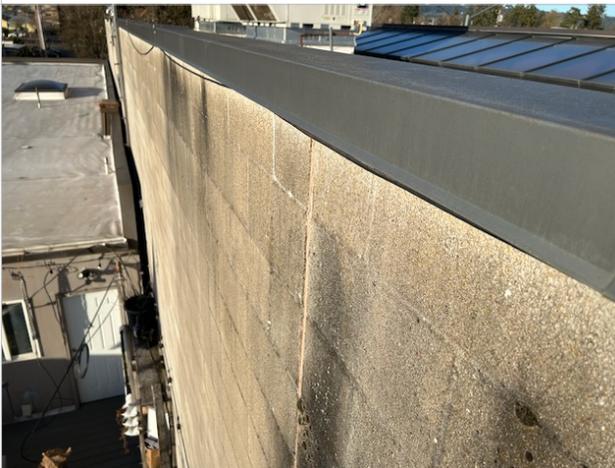
HM#5: CMU Mortar

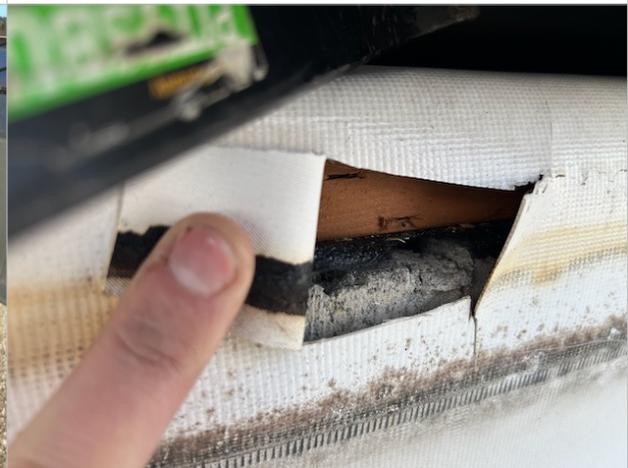
HM#6: Tar Paper, Black, under Flashing

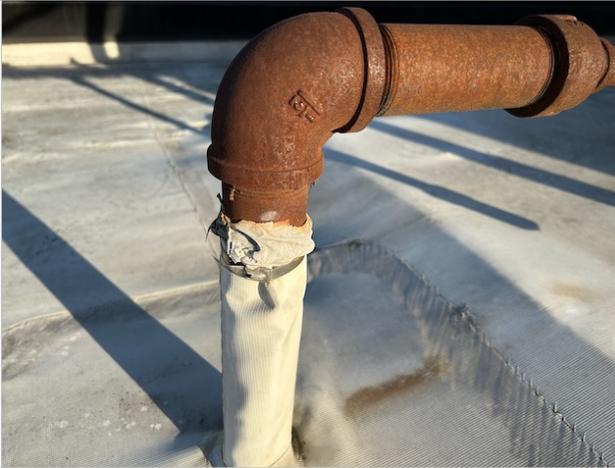
HM#7: Sealant, Off-White, around Penetrations

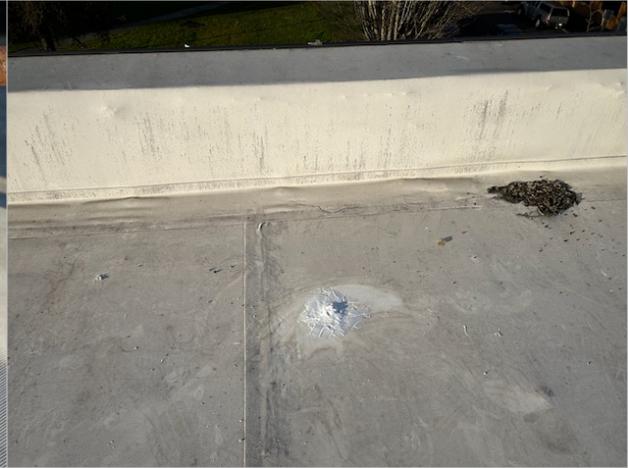
HM#8: Membrane Roof Core #2

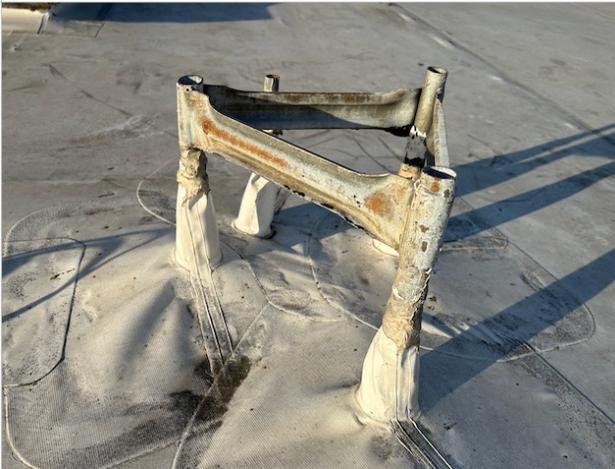
HM#9: Sealant, Light Gray, around Penetrations

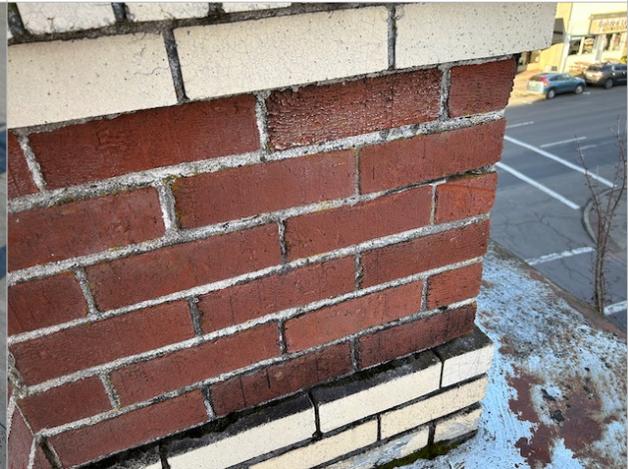
HM#10: Brick Mortar

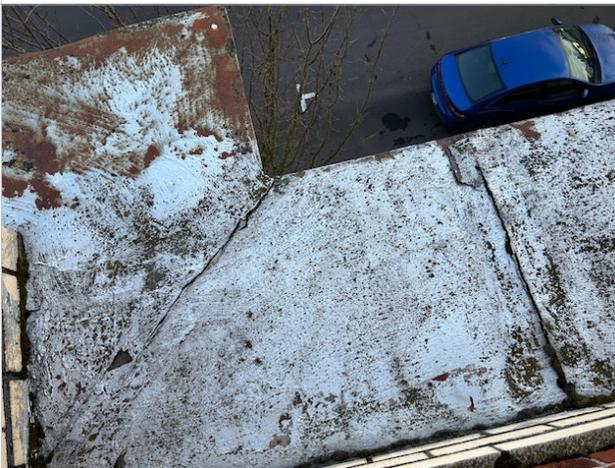
Asbestos-Containing Materials Identified or Presumed							
HM No.†	Material Description	Material Location*	Approx. Quantity*	No. of Samples	Asb. Type & %	Condition	Friable Y/N
11	Silver Paint and Black Tar	East Roof - Decorative Ledge	280 sq. ft.	3	Silver Paint - None Detected Black Tar - Chrysotile 5-20%	Poor	N

HM#11: **Silver Paint and Black Tar**

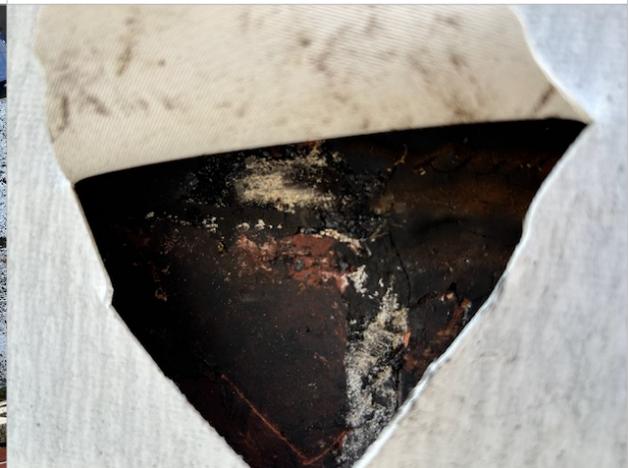
HM#12: Residual Black Tar
