**Enclosed Seismic Rehabilitation Reports**

Seismic Evaluation Report For:

## JOHN TUCK ELEMENTARY SCHOOL

209 NW 10th St, Redmond, OR 97756  
Redmond School District

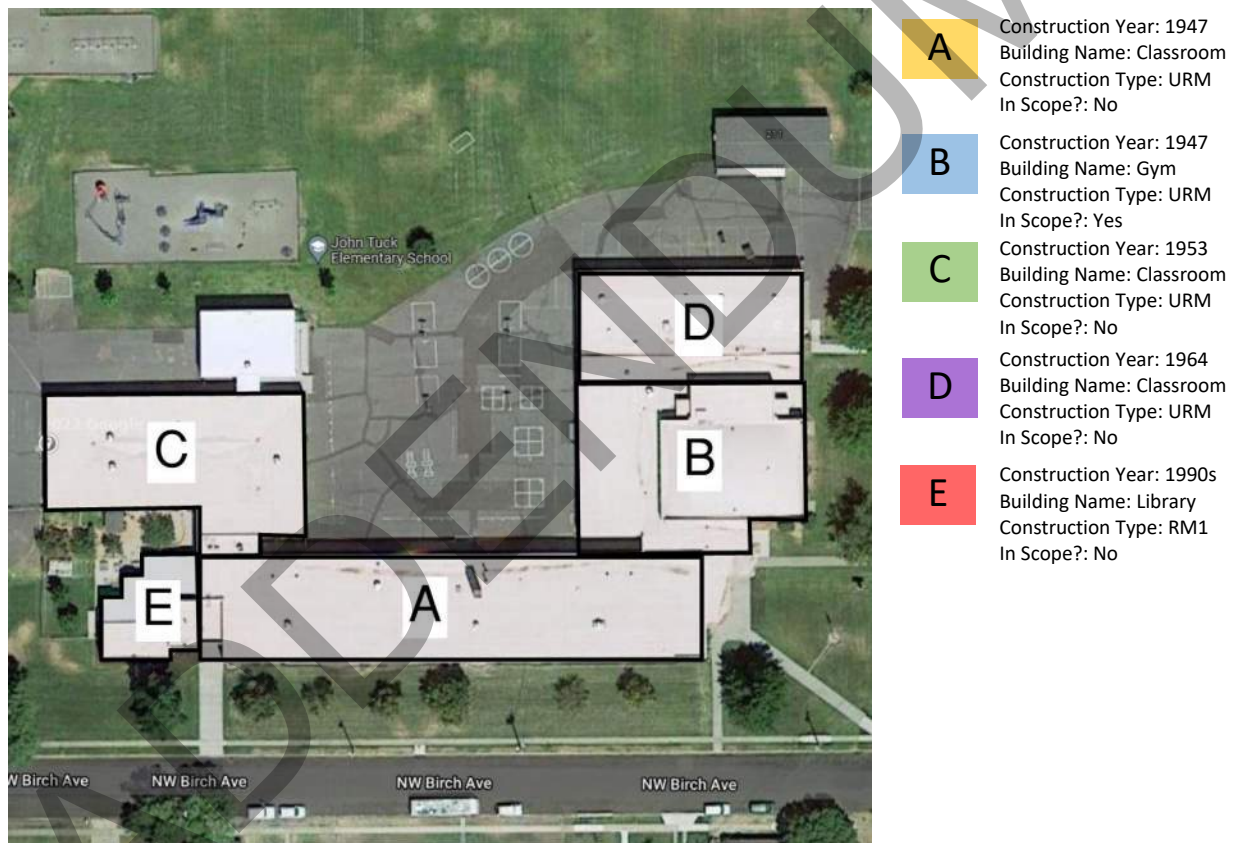
Figure 1  
John Tuck Elementary Key Plan

The John Tuck Elementary School gymnasium was constructed in 1947 including and consists of CMU bearing walls with exterior brick veneer. The roof structure consists of straight sheathing over wood joists supported by heavy timber bowstring trusses. The walls consist of under-reinforced CMU walls bearing over continuous reinforced concrete footings and slab-on-grade foundation. The gymnasium has an approximate floor area of 13,500-square-feet. Photographs of the building parts included in this report are located in Appendix A.

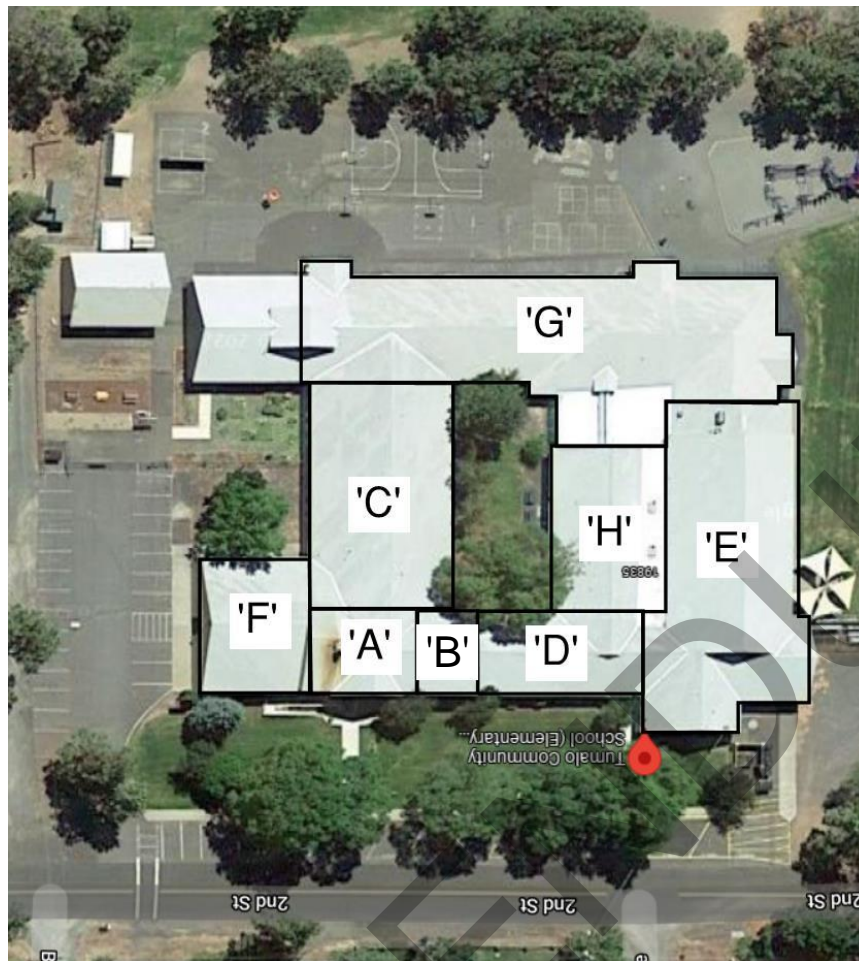
**Figure 1**  
Tumalo Community School Key Plan

<b>A</b>	Building Name: Admin In Scope?: No
<b>B</b>	Building Name: Classroom In Scope?: No
<b>C</b>	Building Name: Classroom In Scope?: No
<b>D</b>	Construction Year: 1950 Building Name: Classroom Construction Type: URM In Scope?: Yes
<b>E</b>	Construction Year: 1958 Building Name: Gymnasium Construction Type: URM In Scope?: Yes
<b>F</b>	Building Name: Library In Scope?: No
<b>G</b>	Building Name: Classroom In Scope?: No
<b>H</b>	Construction Year: 1986 Building Name: Classroom Construction Type: URM In Scope?: Yes

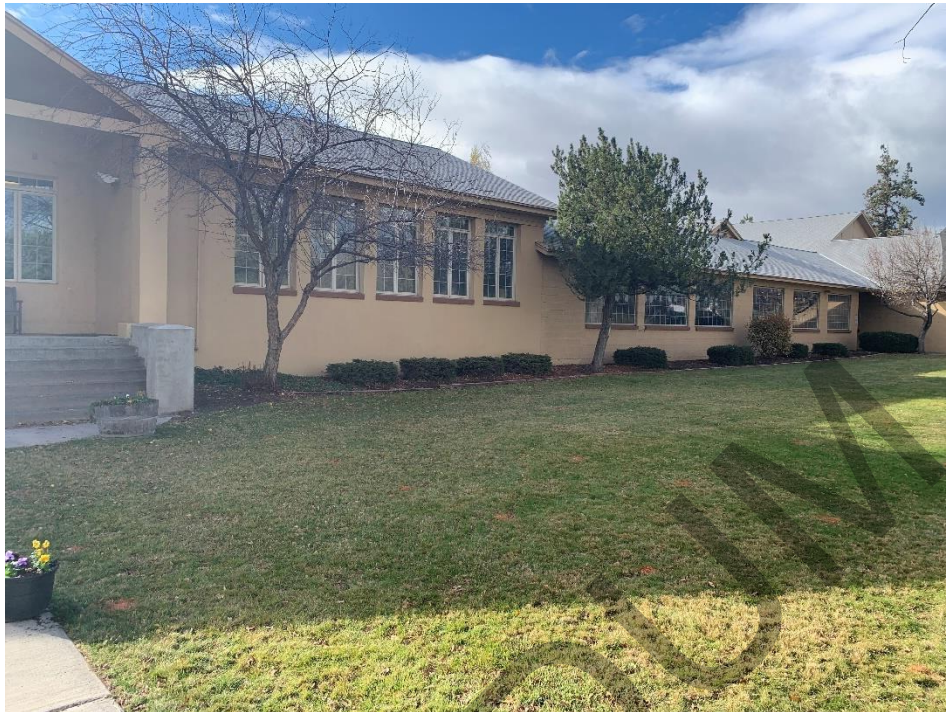
Figure 3: BUILDING 'D' NORTH ELEVATION

Classroom area 'D' was constructed in the 1950s with an approximate footprint of 2,600-square-feet. The roof consists of wood trusses with straight sheathed roof diaphragm supported by under reinforced masonry walls. This structure has been classified as URM due to the lack of adequate reinforcement. Foundations consist of slab-on-grade with continuous reinforced concrete footings.
